Manhole Inspection Summary

Manhole # S37CC_019MH

Insp Date: **3/20/07 1:15 PM**

Location Address: **1021 BRENT WOOD AVE**

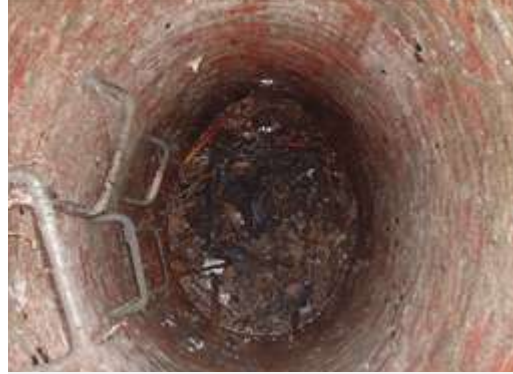
Top View

Channel debris.

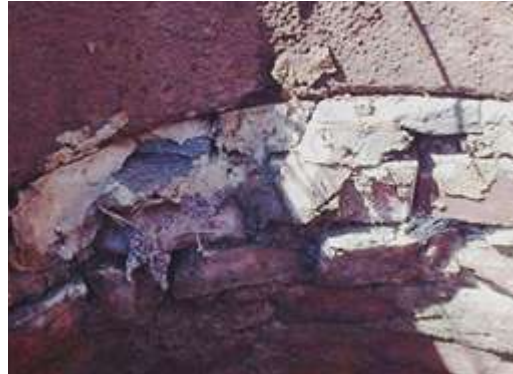
Defect

Frame leaks. Adjustment deterioration, loose brick, root intrusion and infiltration. Corbel deterioration and infiltration.

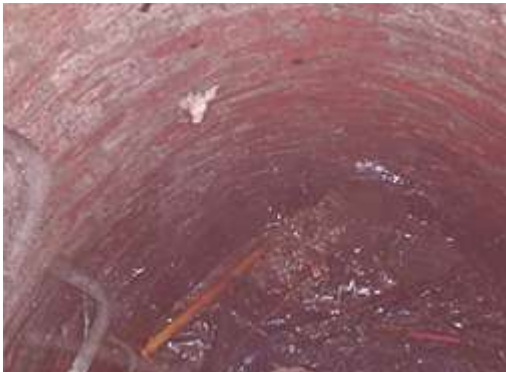
Defect

Active Barrel infiltration.

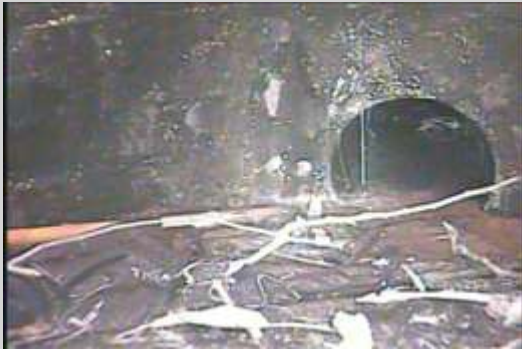
8 in. Circular Gravity Sewer
Pipe Out @ 12 O'Clock

Barrel infiltration (Active).
